MID -AIR COLLISION BETWEEN AN ASK 21 AND AN ASK 13 NEAR LASHAM ON 5 AUGUST 2011

Preliminary Information

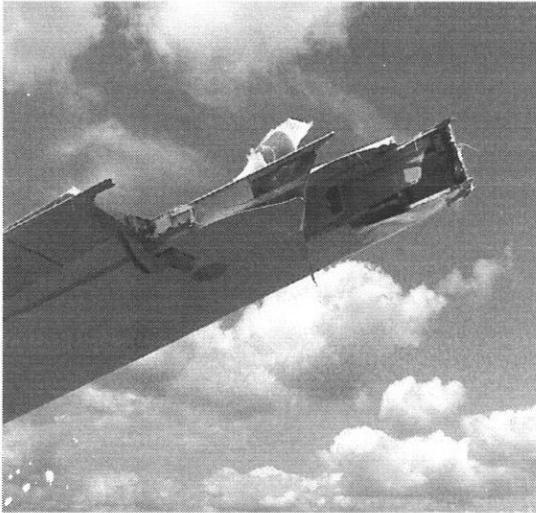
ASK 13

The K13, a Lasham based glider, lost approximately the outer 5 feet of its right wing, which included the outer half of the aileron, outboard of the drive rod/mass balance weight. This was located the following day in a small wood at the western end of the main runway. The K21, a Booker based glider, sustained relatively localised crushing damage to the leading edge of the right wing ahead of the airbrake box, with additional damage to the spar and shear web in this area, see below.
